# Comprehensive Evaluation and Integrated Treatment Research on Slope Stability Based on Multi-Method Coupling for the Bamboo Industrial Park in Huitong County

**Abstract:** This study addresses the stability and treatment issues of high-steep mixed slopes at the Bamboo Industrial Park in Huitong County, employing a multi-method coupling analysis combining the Limit Equilibrium Method (Bishop's method) and the Stereographic Projection Method. Quantitative calculations indicate that the slopes are in a marginally stable to basically stable state under natural conditions ( $F_s=0.986-1.214$ ), but become unstable under saturated conditions ( $F_s=0.743-0.903$ ), revealing that rainfall infiltration is the dominant triggering factor. Stereographic projection analysis further identifies multiple sets of unfavorable structural planes in the rock slopes, which are prone to wedge-shaped collapses and planar sliding. Based on this, a differentiated "zoned and classified" comprehensive treatment strategy is proposed, constructing an integrated technical system of "support and reinforcement - three-dimensional drainage - ecological restoration - full-cycle monitoring". This provides a compl

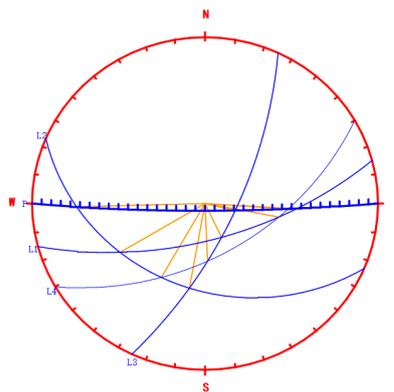
**Figure 1:** The Stereographic Projection Analysis Diagram of Rock Mass Structural Plane Of Rock Slope After Excavation in Zone A

Stereographic Projection Analysis (refer to Figures 1, 2). Plotting the above structural planes and the slope face ( $0^\circ/75^\circ$ ) on the same stereographic net shows:

The dip directions of Joint Set ② ( $30^\circ \angle 57$ - $65^\circ$ ) and Joint Set ④ ( $55^\circ \angle 35$ - $42^\circ$ ) have small angles ( $30^\circ$ - $55^\circ$ ) with the slope dip direction ( $0^\circ$ ), belonging to "dip slope" or "oblique dip slope" structural planes.

The dip angle of Joint Set ② ( $57$ - $65^\circ$ ) is less than the slope angle ( $75^\circ$ ). Its intersection line with other sets outcrops on the slope face, and the plunge of the intersection line is less than the slope angle but greater than the rock mass friction angle, meeting the conditions for wedge sliding.

The dip angle of Joint Set ④ is relatively gentle ( $35$ - $42$ ). Although less than the slope angle, its combination with the slope face alone easily forms unstable blocks.

The rock slope in Zone A belongs to an unstable structure. The main failure modes are wedge-shaped collapse or sliding formed by the combination of Joint Sets ②, ④, and other joint sets (such as ① or ③). There is also a risk of planar sliding along Joint Set ④. After slope excavation, the formation of free faces makes local rock block collapse and spalling highly likely.

In rock slope sections, a combined scheme of “systematic (or active) protective netting + local rock bolt (cable) reinforcement + toe retaining wall” is adopted. Protective netting prevents shallow collapses and spalling; bolts (cables) reinforce potential unstable wedges; the toe wall bears rockfall and protects the slope toe.

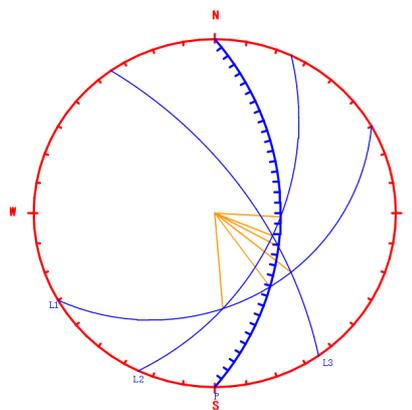
**Figure 3:** The Stereographic Projection Analysis Diagram of Rock Mass Structural Plane of Rock Slope After Excavation in Zone B.

Rock slope section on the west side of Zone B, slope dip direction  $90^\circ$  (due east), slope angle  $40^\circ$ - $60^\circ$ . Multiple joint sets similar to Zone A are developed. Stereographic Projection Analysis (refer to Figure 3): Plotting the main structural planes and the slope face ( $90^\circ/50^\circ$ ) for analysis shows:

Joint Set ① ( $105^\circ \angle 52$ - $56^\circ$ ) dips obliquely to the slope face ( $90^\circ$ ) with an angle of  $15^\circ$ , and its dip angle is greater than the slope angle, indicating a relatively lower degree of disadvantage.

The dip directions of Joint Set ② ( $30^\circ \angle 57$ - $65^\circ$ ) and Joint Set ④ ( $55^\circ \angle 35$ - $42^\circ$ ) are nearly opposite or intersect the slope dip direction at a large angle, which is unfavorable for downslope sliding.

However, attention should be paid to the possible existence of other gently dipping structural planes, not yet detailedly exposed, dipping eastward (consistent with the slope direction).

Based on the analysis of existing main structural planes, the overall stability of the rock slope in Zone B is slightly better than that of Zone A, but it still falls under basically stable to marginally stable. Under external forces such as rainfall infiltration and vibration, the falling of irregular blocks formed

by the intersection of multiple joint sets is the main risk. Construction excavation disturbance may activate new potential sliding surfaces.

At Soil-Rock/Rock Slopes, recommend “cut-back slope + anchor (cable) lattice beam slope protection” or “stepped slope + ecological bag slope protection.” Targeted bolt reinforcement should be applied to identified unstable wedges.
