Comprehensive Evaluation and Integrated Treatment Research on Slope Stability Based on Multi-Method Coupling for the Bamboo Industrial Park in Huitong County

Abstract: This study addresses the stability and treatment issues of high-steep mixed slopes at the Bamboo Industrial Park in Huitong County, employing a multi-method coupling analysis combining the Limit Equilibrium Method (Bishop's method) and the Stereographic Projection Method. Quantitative calculations indicate that the slopes are in a marginally stable to basically stable state under natural conditions ($F_s=0.986-1.214$), but become unstable under saturated conditions ($F_s=0.743-0.903$), revealing that rainfall infiltration is the dominant triggering factor. Stereographic projection analysis further identifies multiple sets of unfavorable structural planes in the rock slopes, which are prone to wedge-shaped collapses and planar sliding. Based on this, a differentiated "zoned and classified" comprehensive treatment strategy is proposed, constructing an integrated technical system of "support and reinforcement - three-dimensional drainage - ecological restoration - full-cycle monitoring". This provides a complete soluti

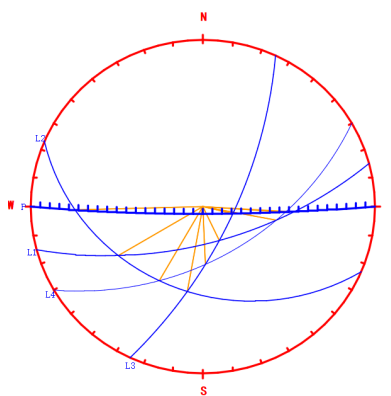
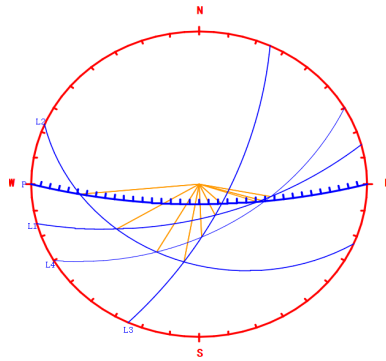
Figure 1: The Stereographic Projection Analysis Diagram of Rock Mass Structural Plane Of Rock Slope After Excavation in Zone A

Stereographic Projection Analysis (refer to Figures 1, 2). Plotting the above structural planes and the slope face ($0^\circ/75^\circ$) on the same stereographic net shows:

The dip directions of Joint Set ② ($30^\circ \angle 57$ - 65°) and Joint Set ④ ($55^\circ \angle 35$ - 42°) have small angles (30° - 55°) with the slope dip direction (0°), belonging to "dip slope" or "oblique dip slope" structural planes.

The dip angle of Joint Set ② (57 - 65°) is less than the slope angle (75°). Its intersection line with other sets outcrops on the slope face, and the plunge of the intersection line is less than the slope angle but greater than the rock mass friction angle, meeting the conditions for wedge sliding.

The dip angle of Joint Set ④ is relatively gentle (35 - 42). Although less than the slope angle, its combination with the slope face alone easily forms unstable blocks.

The rock slope in Zone A belongs to an unstable structure. The main failure modes are wedge-shaped collapse or sliding formed by the combination of Joint Sets ②, ④, and other joint sets (such as ① or ③). There is also a risk of planar sliding along Joint Set ④. After slope excavation, the formation of free faces makes local rock block collapse and spalling highly likely.

In rock slope sections, a combined scheme of “systematic (or active) protective netting + local rock bolt (cable) reinforcement + toe retaining wall” is adopted. Protective netting prevents shallow collapses and spalling; bolts (cables) reinforce potential unstable wedges; the toe wall bears rockfall and protects the slope toe.

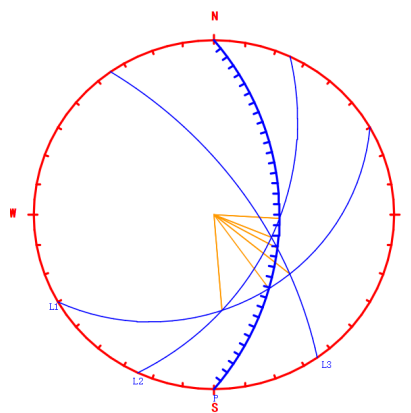
Figure 3: The Stereographic Projection Analysis Diagram of Rock Mass Structural Plane of Rock Slope After Excavation in Zone B.

Rock slope section on the west side of Zone B, slope dip direction 90° (due east), slope angle 40° - 60° . Multiple joint sets similar to Zone A are developed. Stereographic Projection Analysis (refer to Figure 3): Plotting the main structural planes and the slope face ($90^\circ/50^\circ$) for analysis shows:

Joint Set ① ($105^\circ \angle 52$ - 56°) dips obliquely to the slope face (90°) with an angle of 15° , and its dip angle is greater than the slope angle, indicating a relatively lower degree of disadvantage.

The dip directions of Joint Set ② ($30^\circ \angle 57$ - 65°) and Joint Set ④ ($55^\circ \angle 35$ - 42°) are nearly opposite or intersect the slope dip direction at a large angle, which is unfavorable for downslope sliding.

However, attention should be paid to the possible existence of other gently dipping structural planes, not yet detailedly exposed, dipping eastward (consistent with the slope direction).

Based on the analysis of existing main structural planes, the overall stability of the rock slope in Zone B is slightly better than that of Zone A, but it still falls under basically stable to marginally stable. Under external forces such as rainfall infiltration and vibration, the falling of irregular blocks formed

by the intersection of multiple joint sets is the main risk. Construction excavation disturbance may activate new potential sliding surfaces.

At Soil-Rock/Rock Slopes, recommend “cut-back slope + anchor (cable) lattice beam slope protection” or “stepped slope + ecological bag slope protection.” Targeted bolt reinforcement should be applied to identified unstable wedges.
